DEPARTMENT OF TRANSPORTATION**DIVISION OF ENGINEERING SERVICES**

Quality Assurance and Source Inspection

Contract #: 04-0120F4Cty: SF/ALA Rte: 80 PM: 13.2/13.9File #: 99.28**WELDING INSPECTION REPORT****Resident Engineer:** Siegenthaler, Peter**Address:** 333 Burma Road**City:** Oakland, CA 94607**Report No:** WIR-020131**Date Inspected:** 26-Dec-2010**Project Name:** SAS Superstructure**OSM Arrival Time:** 700**Prime Contractor:** American Bridge/Fluor Enterprises, a JV**OSM Departure Time:** 1900**Contractor:** Zhenhua Port Machinery Company, Ltd (ZPMC) Chanxing Island**Location:** Shanghai, China**CWI Name:** Mr. LIU HUA JIE**CWI Present:** Yes No**Inspected CWI report:** Yes No N/A**Rod Oven in Use:** Yes No N/A**Electrode to specification:** Yes No N/A**Weld Procedures Followed:** Yes No N/A**Qualified Welders:** Yes No N/A**Verified Joint Fit-up:** Yes No N/A**Approved Drawings:** Yes No N/A**Approved WPS:** Yes No N/A**Delayed / Cancelled:** Yes No N/A**Bridge No:** 34-0006**Component:** OBG Segment**Summary of Items Observed:**

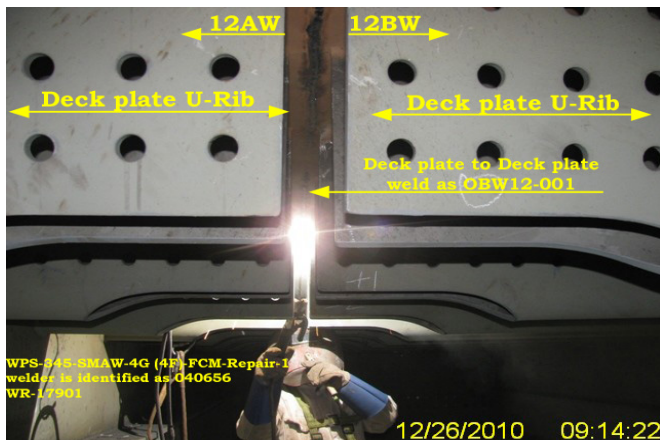
ZPMC welding personnel performing Shielded Metal Arc Welding (SMAW) of Repair weld for the deck plate to deck plate transverse splice weld joint located on 12AW+12BW. The weld is designated as OBW12-001. The welder is identified as 040656. ZPMC QC Mr. ZHOU PENG was onsite monitoring the welding variables. The inprocess SMAW appears to be progressing in compliance with WPS-345-SMAW-4G (4F)-FCM-Repair-1. The weld repair report number is named as WR-17901. Further weld detail mention in attached picture.
